**BLACK BRANT IV LF/VLF ROCKET PROBE  
EXPERIMENT**

**Aerospace Research, Incorporated**

**Air Force Cambridge Research Laboratories**

Final Report

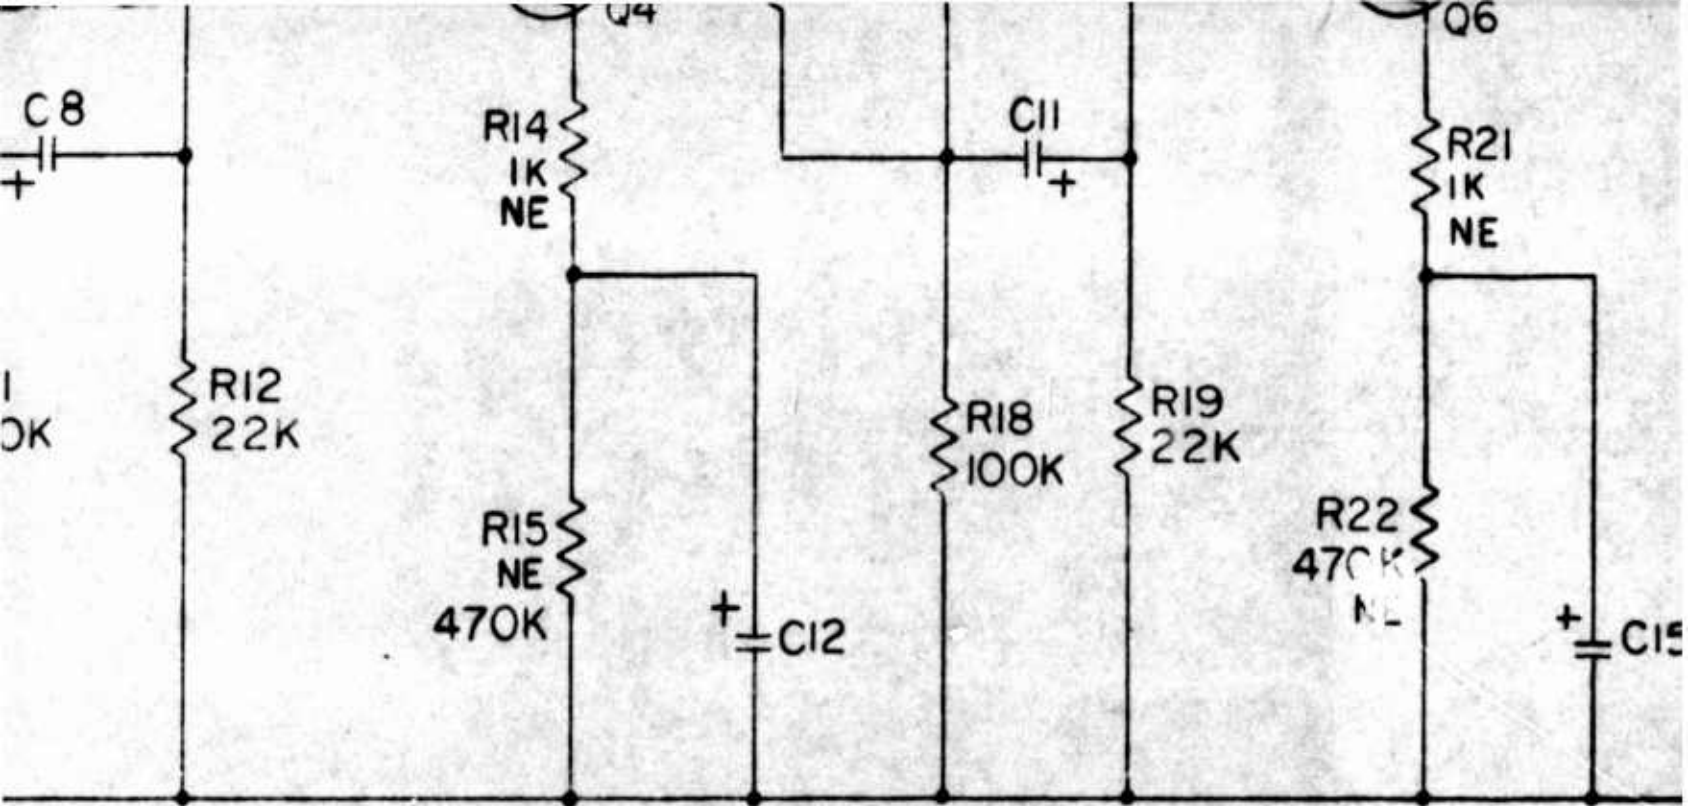
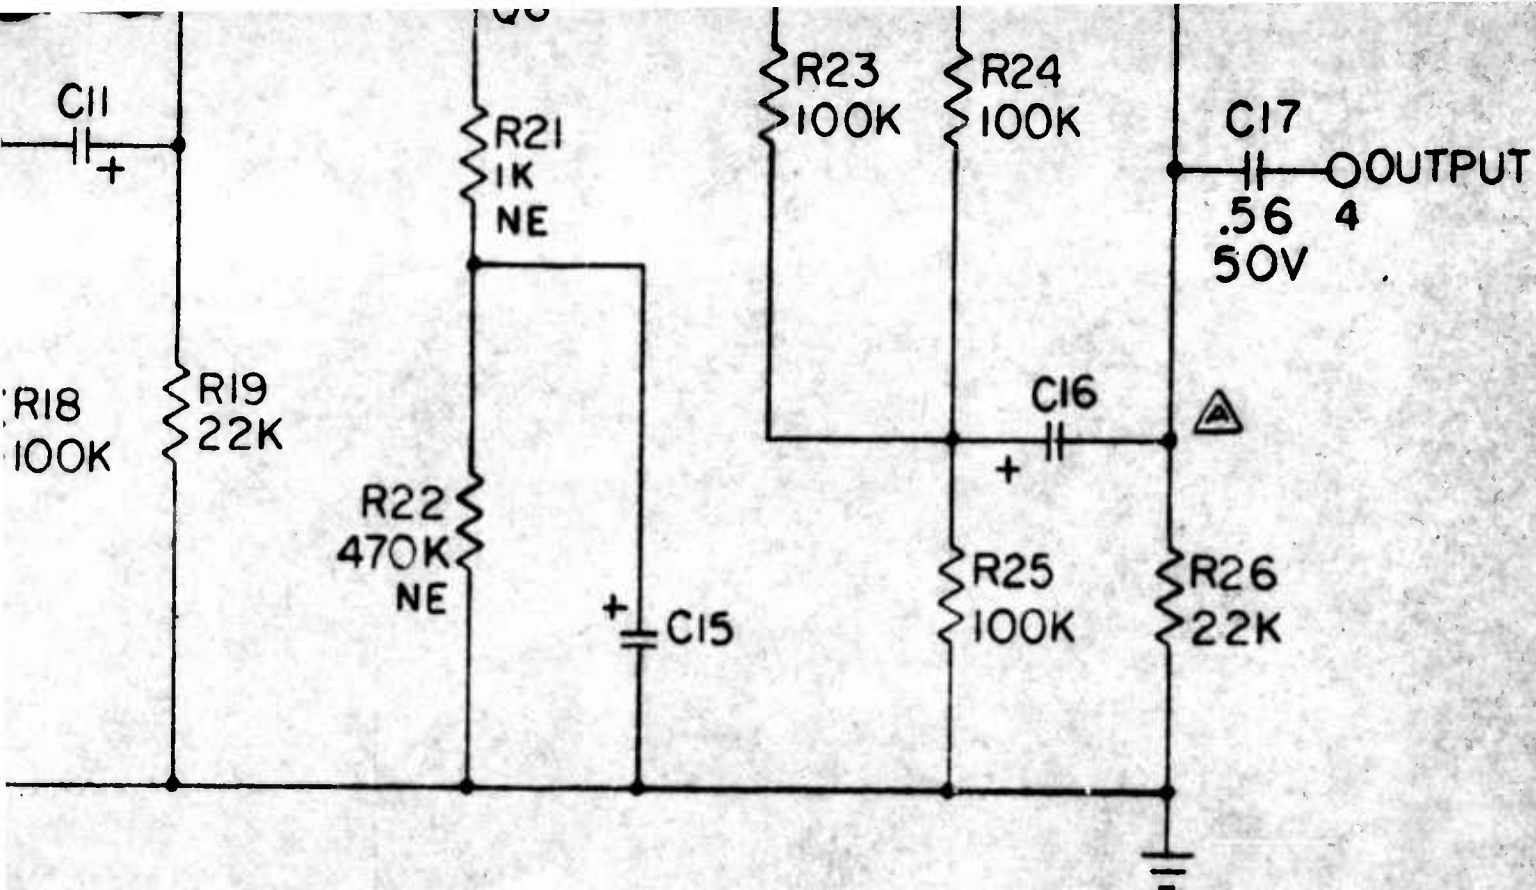
REQD.	REQD.	ITEM	PART NO.	DESCRIPTION
LIST OF MATERIALS				
REMOVE ALL BURRS & BREAK SHARP EDGES DO NOT SCALE DIMS. TOLERANCES UNLESS OTHERWISE SPECIFIED PRACT. 41/84 DEC. SPL. SPL. 0.000 ANG.		<b>RECEIVER CIRCUIT            SCHEMATIC-            BB IV VLF ROCKET EXP</b>

1. ALL RESISTORS ARE  $\frac{1}{4}W, \pm 10\%$ .
2. ALL TRANSISTORS ARE 2N3392.
3. ALL CAPACITORS ARE  $6.8\mu f, 35V$ .
4. L1, L3 ARE TOROTEL PC51-I.
5. L2 TENCO ARI T8528.

The original design of the receiver card called for three gain stages; the first and third stages were relatively wideband while the second stage, a high Q stage, provided most of the gain and was actually where the bandwidth of the receiver was determined. In this configuration, it was difficult to tune the card because the majority of the gain was in one stage. There was also the possibility that more overall gain in the narrow band condition would be required as the result of having to broadband the card to receive FSK signals since there were no stations transmitting regularly scheduled CW broadcasts.

It was decided to divide the gain equally among the three stages by making the inductors - L1, L2, and L3 - 3 mH coils having a minimum Q of 250 at 20 kHz. The values of L1, L2 and L3 had been 1 mH, 5 mH, and 1 mH respectively. The change in inductors, combined with the substitution of Q3 and Q7 from normal bi-polar to field effect transistors (FET), resulted in the possibility of approximately 40 dB gain per stage, and a maximum of 120 dB gain in the very narrow band position. The bandwidth of the modified card was found to be about 50 to 60 Hz. Another positive feature of the modified coils is that they are slug tunable, which made it possible to solder a fixed capacitance and to fine tune the inductor rather than resorting to the hit -and-miss placement of small capacitance.

The 20 dB switch was maintained so the gain of the payload would be switched by 20 dB as before. The switching mechanism, Q2, was changed to a FET to allow fewer transients in the switching cycle. It had been noticed that at times during a switch from high to low gain, a transient appeared, making that portion of the data unusable; the use of the new switch corrected the problem and the transient was no longer observed.
